Polyethylene liner dissociation in total hip arthroplasty: a retrospective case–control study on a single implant design

Abstract

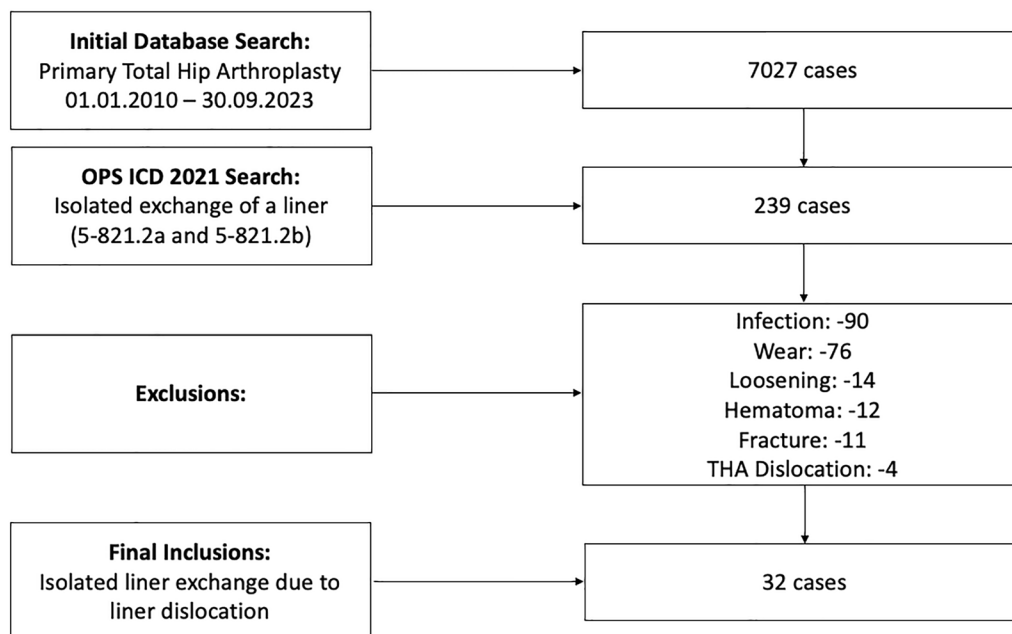
Fig. 1 Flowchart illustrating the database search process divided into two distinct categories: primary total hip arthroplasty (THA) and THA revision refined using specific OPS codes for isolated exchange of the liner

note review, were included in the final analysis. After this selection process, the final cohort consisted of 32 patients suitable for analysis and a comprehensive set of data was collected from the internal clinical database (ORBIS, Agfa healthcare) including patient demographics, surgical variables, and clinical findings (Fig. 1).

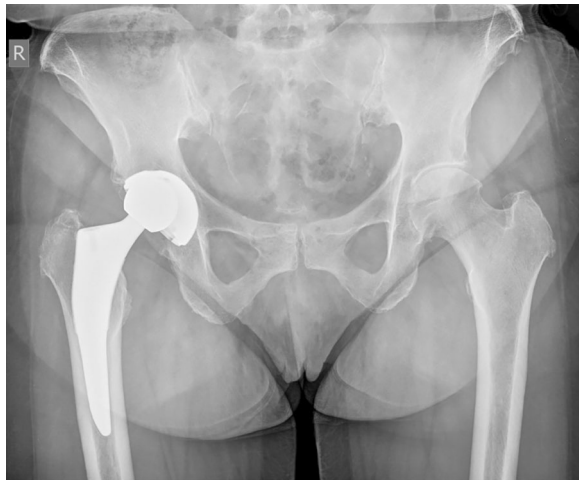
Fig. 2 Anteroposterior X-ray of the pelvis showing a dislocation of the femoral head caused by liner dissociation from the acetabular cup. The image clearly depicts the contact of the dislocated femoral head with the acetabular cup

Diagnosis is typically straightforward, as evidenced by the lateralization of the femoral head on X-rays and audible hip squeaking. Early diagnosis is fundamental to minimize potential damage to the acetabular cup, subsequently reducing the complexity of revision surgeries.

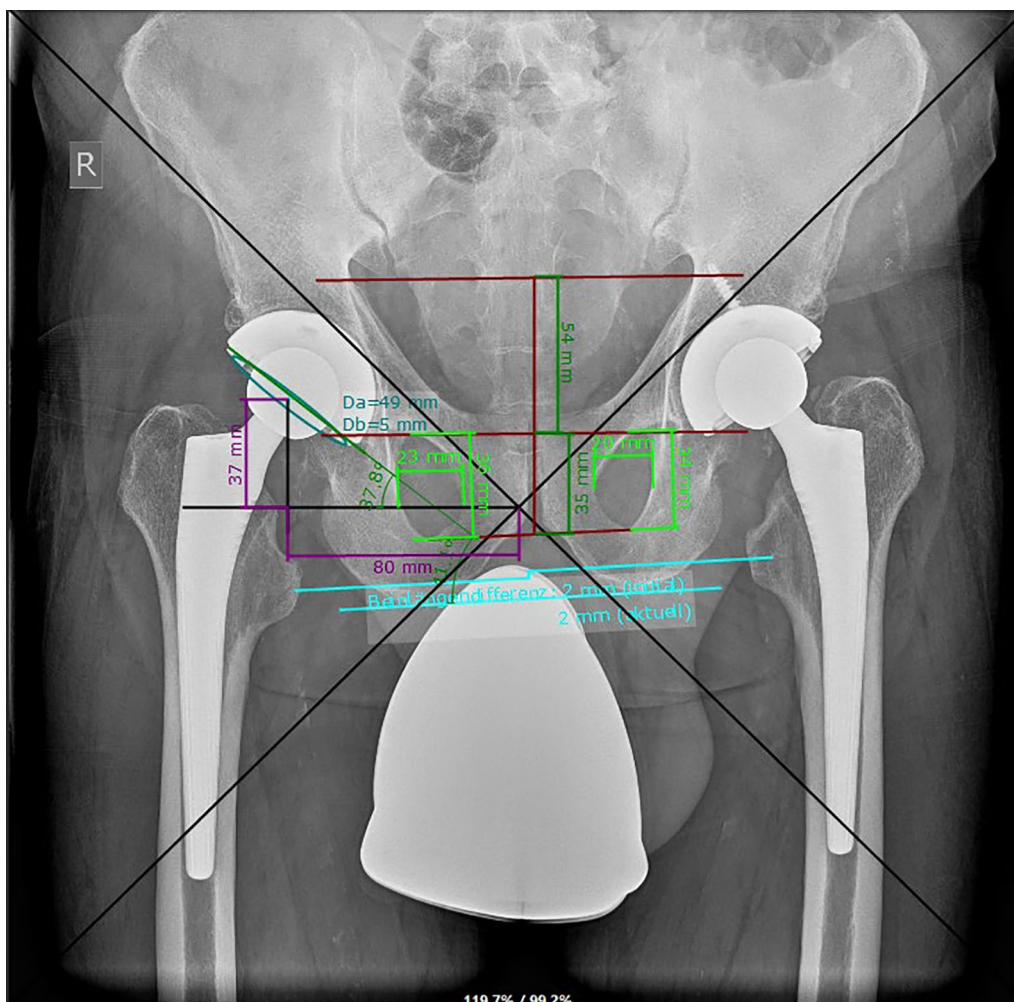
Fig. 3 The acquired values were input into an algorithm that calculated the acetabular cup's anteversion and inclination on the anterior pelvis plane (APP) and the vertical functional coronary plane (FCP)

To evaluate the acetabular anteversion and inclination on both the anterior pelvis plane (APP) and the vertical functional coronary plane (FCP) (Fig. 3), we utilized an algorithmic model developed by Schwarz et al. [16, 17]. This model helps accurately assess the orientation of the acetabular cup on pelvic radiographs by correcting for potential errors caused by the positioning of the X-ray beam. Specifically, it adjusts for deviations in the central beam that can lead to inaccurate measurements of cup anteversion and inclination. The algorithm takes into account the effects of pelvic tilt and rotation, which can distort the appearance of the cup on radiographs. By applying mathematical corrections, it compensates for these distortions, allowing for a more accurate assessment of the cup's orientation [16, 17]. Experimental results using a dummy pelvis demonstrated that the corrected measurements had an average absolute difference of only 0.4° for anteversion and 0.3° for inclination, compared with other methods that showed much larger errors [16]. Additionally, the algorithm was tested with various pelvic positions, confirming its robustness across different scenarios [17].

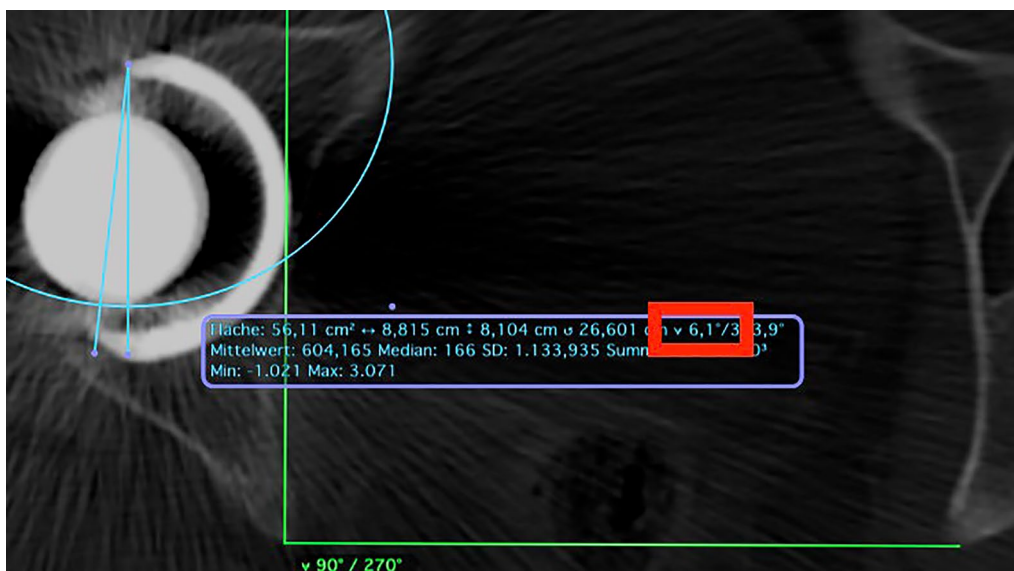
Fig. 4 Rotational CT scans of the lower extremities were assessed using the software OsirixLite (Pixmeo, Bernex, Switzerland). In the provided example, the cup's anteversion is measured

For the rotational CT scans of the lower extremities, we utilized OsirixLite software (Pixmeo, Bernex, Switzerland) to assess the images. In the CT scans, we determined the acetabular cup anteversion on the APP, the stem anteversion, and the combined anteversion. To measure the CT scans, we adopted the prevalent method in the current literature [19, 20]. The cup's anteversion was determined using the angle between a line that connects the cup's lateral anterior and posterior edges and a perpendicular line linking two symmetrical points on each side of the pelvis. The stem's anteversion, which reflects the relationship between the condylar axis and the stem neck, was measured using a line drawn between the posterior portions of the medial and lateral femoral condyles and another line that joins the centre of the femoral head to the femoral component's neck centre. The combined anteversion was obtained by summing the angle of the cup and the femoral component's anteversion (Fig. 4). All measurements were conducted by a single senior surgical resident (S.P.) and subsequently assessed, verified, and confirmed by a senior surgeon (G.M.).

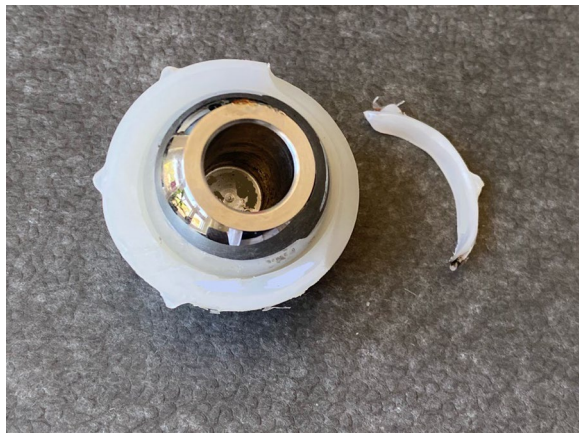
Fig. 5 In this particular case the replaced liner shows damage on one edge, with no signs of wear or ovalization. The image has been edited to obscure the serial numbers

During surgery, the most frequent dislocation direction of the liner was caudal, occurring in eight cases (25.0%). Deformations and broken liners were identified in eight (25.0%) and six (18.8%) patients, respectively (Fig. 5). Metallosis was observed in 17 cases (53.1%), and impingement was evident in 13 cases (40.6%) (Table 4).

Among the patient cohort, four cases during the first revision surgery necessitated not only the replacement of the liner but also the reimplantation of the metal cup due to significant damage. For all other revision surgeries, the procedures generally involved only exchanges of the liner and head components.
